INSTALLATION
RESTORATION PROGRAM

PHASE I - RECORDS SEARCH

ROBINS AFB, GEORGIA

APRIL, 1982

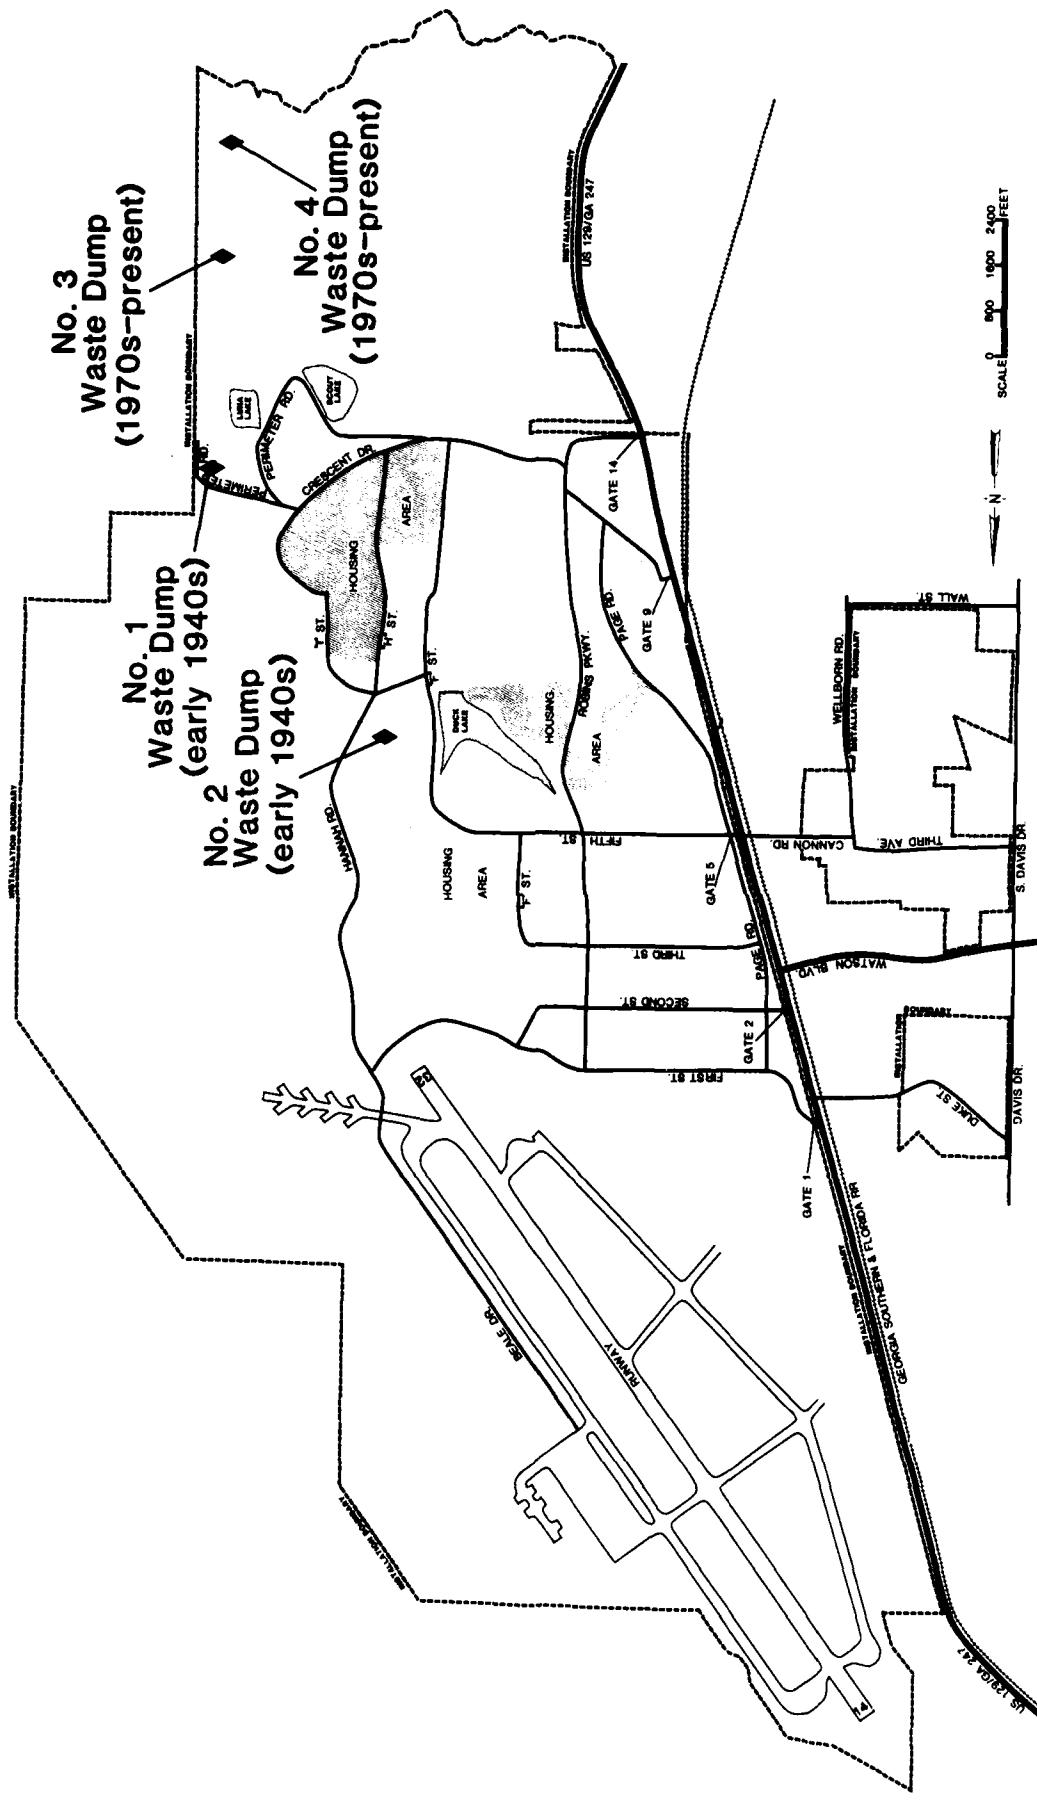
FIGURE 4.9

Four sites on-base were used for general refuse and landscape trash. The general locations of the waste dumps are indicated on Figure 4.9. Waste dump No. 1 and 2 were operated from early 1942 through 1946. The exact method of operation of the waste dumps was not determined. It is speculated that refuse was surface dumped at these sites and burned when it began to accumulate. No daily cover was probably applied,

WASTE DUMP LOCATIONS

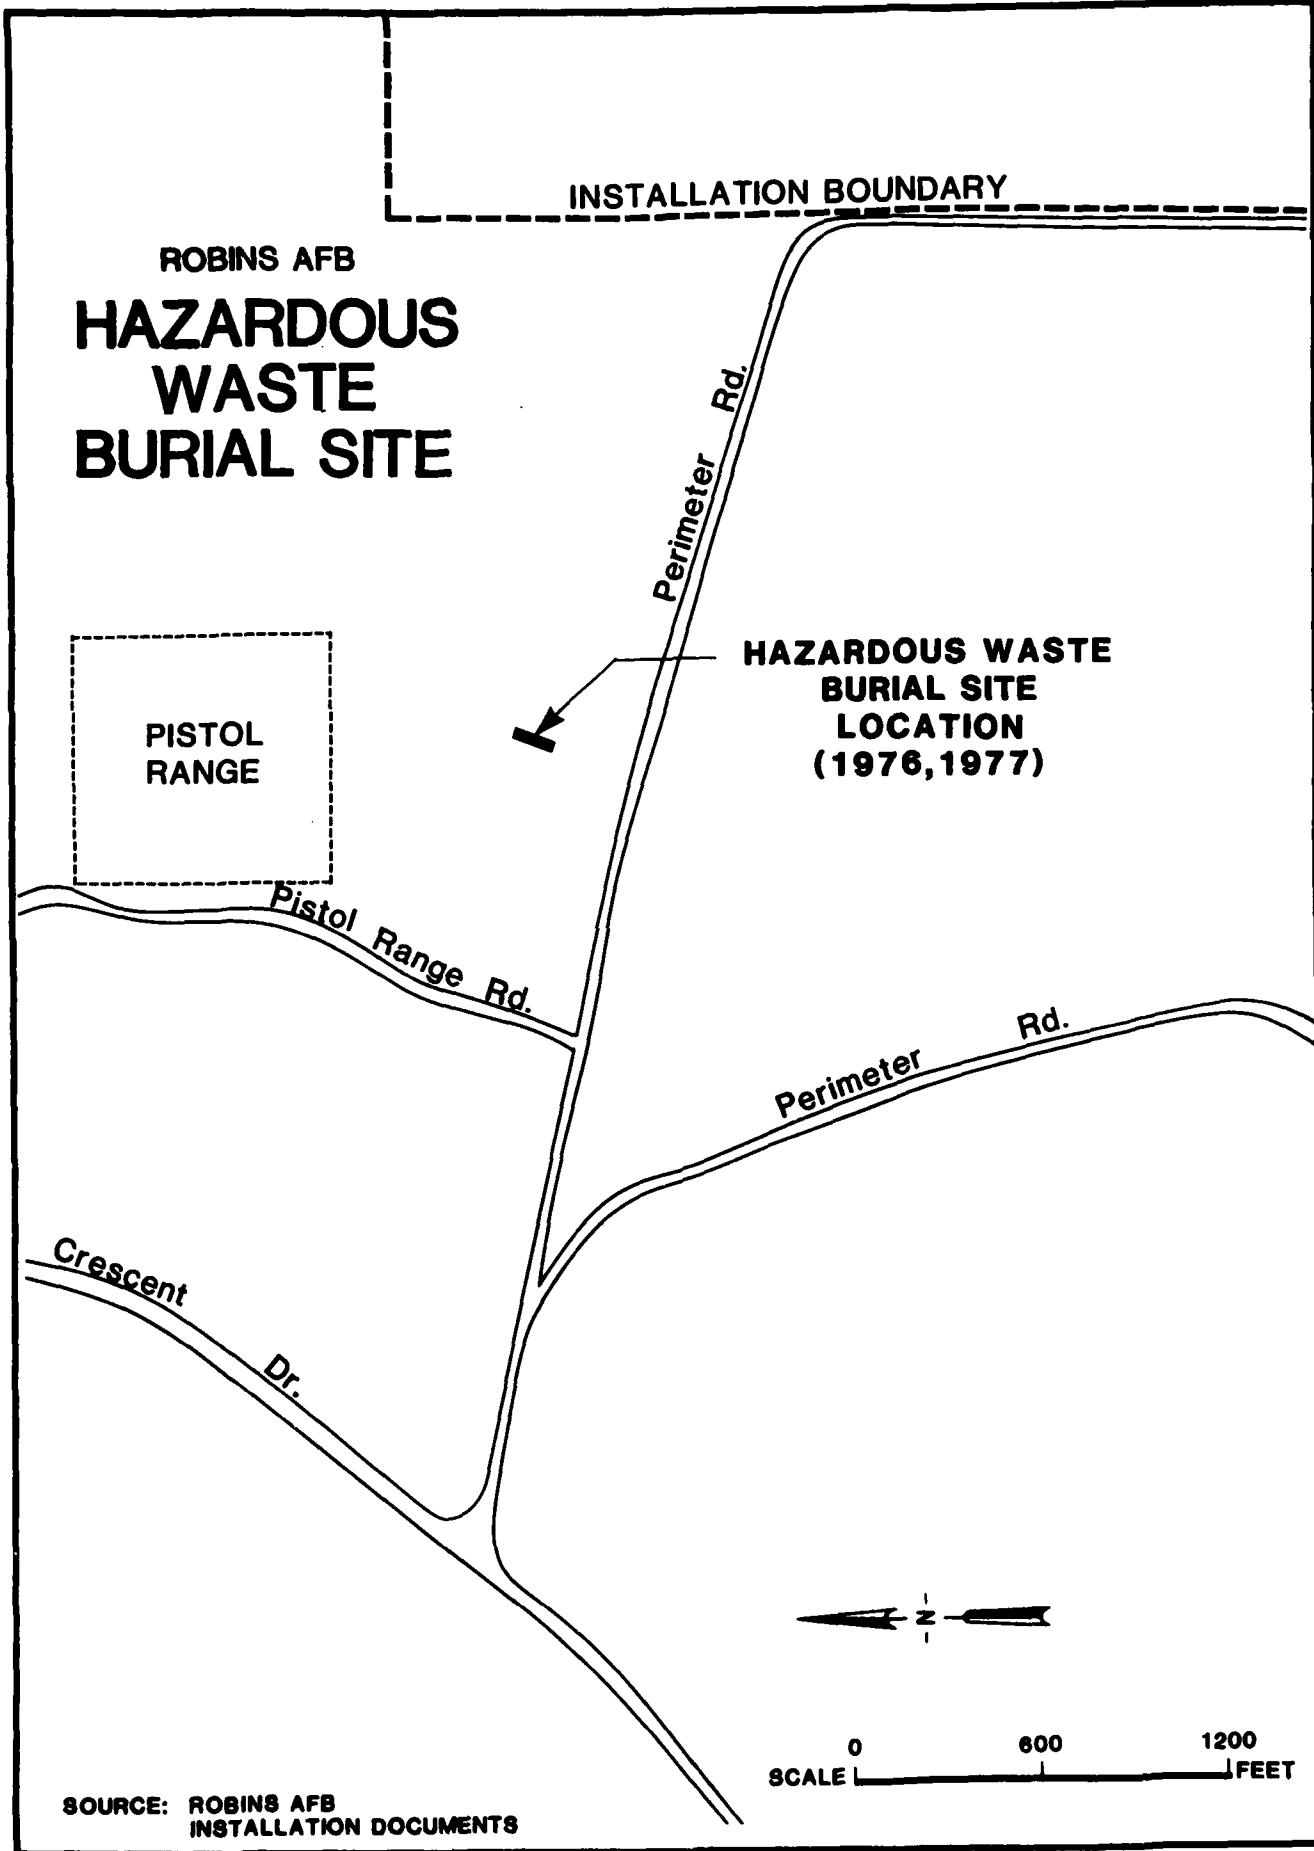
FIGURE 4.10

In January 1976, approximately 240 aerosol cans of DDT with pyrethrin were disposed by burial on the south portion of the base (Figure 4.10). Several sections of 30 inch diameter reinforced concrete pipe 48 inch in length were used as containers. These sections were placed vertically in a trench then capped at the bottom end with concrete. The aerosol cans were placed in the pipe sections. Each pipe section was capped at the top end with concrete for a secure closure. The trench was filled and 24 inches of natural earth cover was placed over the pipe

sections. Similar procedures were used at this same location for disposal of two containers of mercury contaminated material and one container of a small amount of PCB material in April 1976. Approximately 15 gallons of wastes contaminated with mercury were disposed at this location in April 1977. The waste material was placed in plastic bags, then placed in metal containers. The containers were placed in additional plastic bags, then were encapsulated with six inches of concrete prior to final burial. No indication of further waste disposal at this site was determined from the base records and personnel interviews.

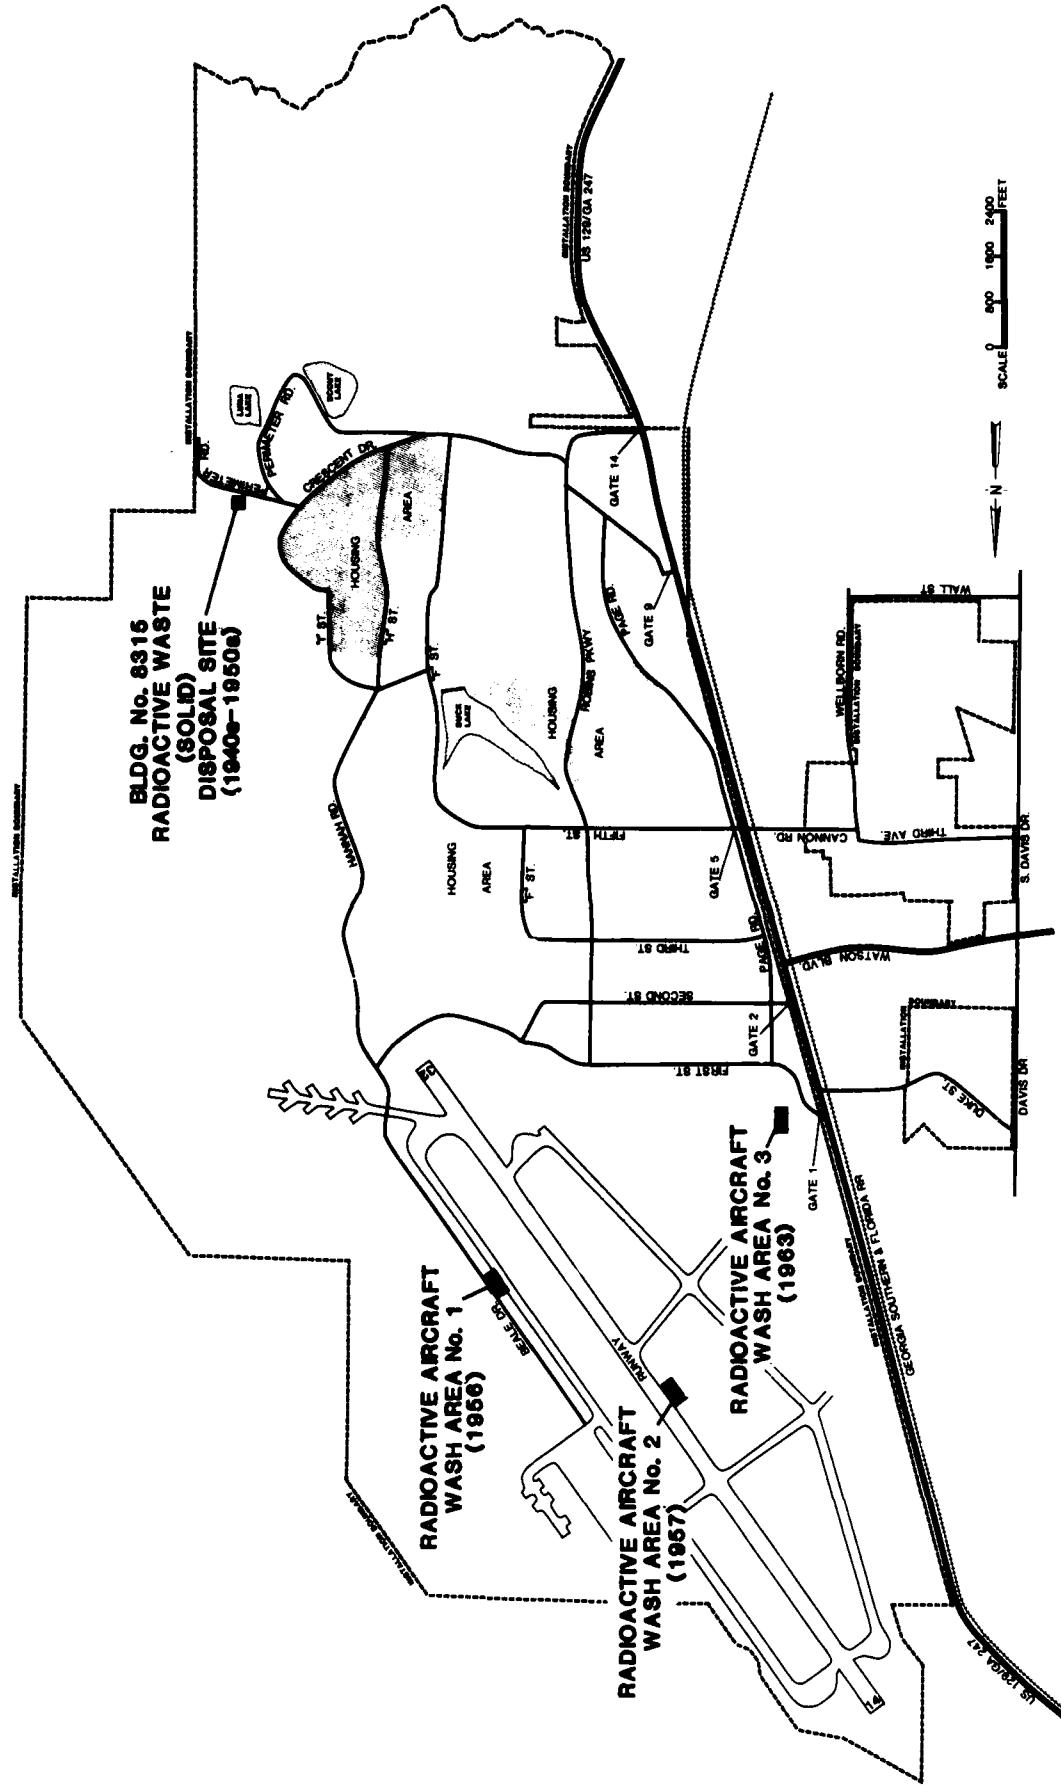
FIGURE 4.11

Low level radioactive wastes have been generated on-base from instrument repair work and washdown of radioactive aircraft. The disposal sites for these wastes occurred in the locations shown in Figure 4.11 and are described below.

RADIOACTIVE WASTE BURIAL SITE & AIRCRAFT WASH AREAS

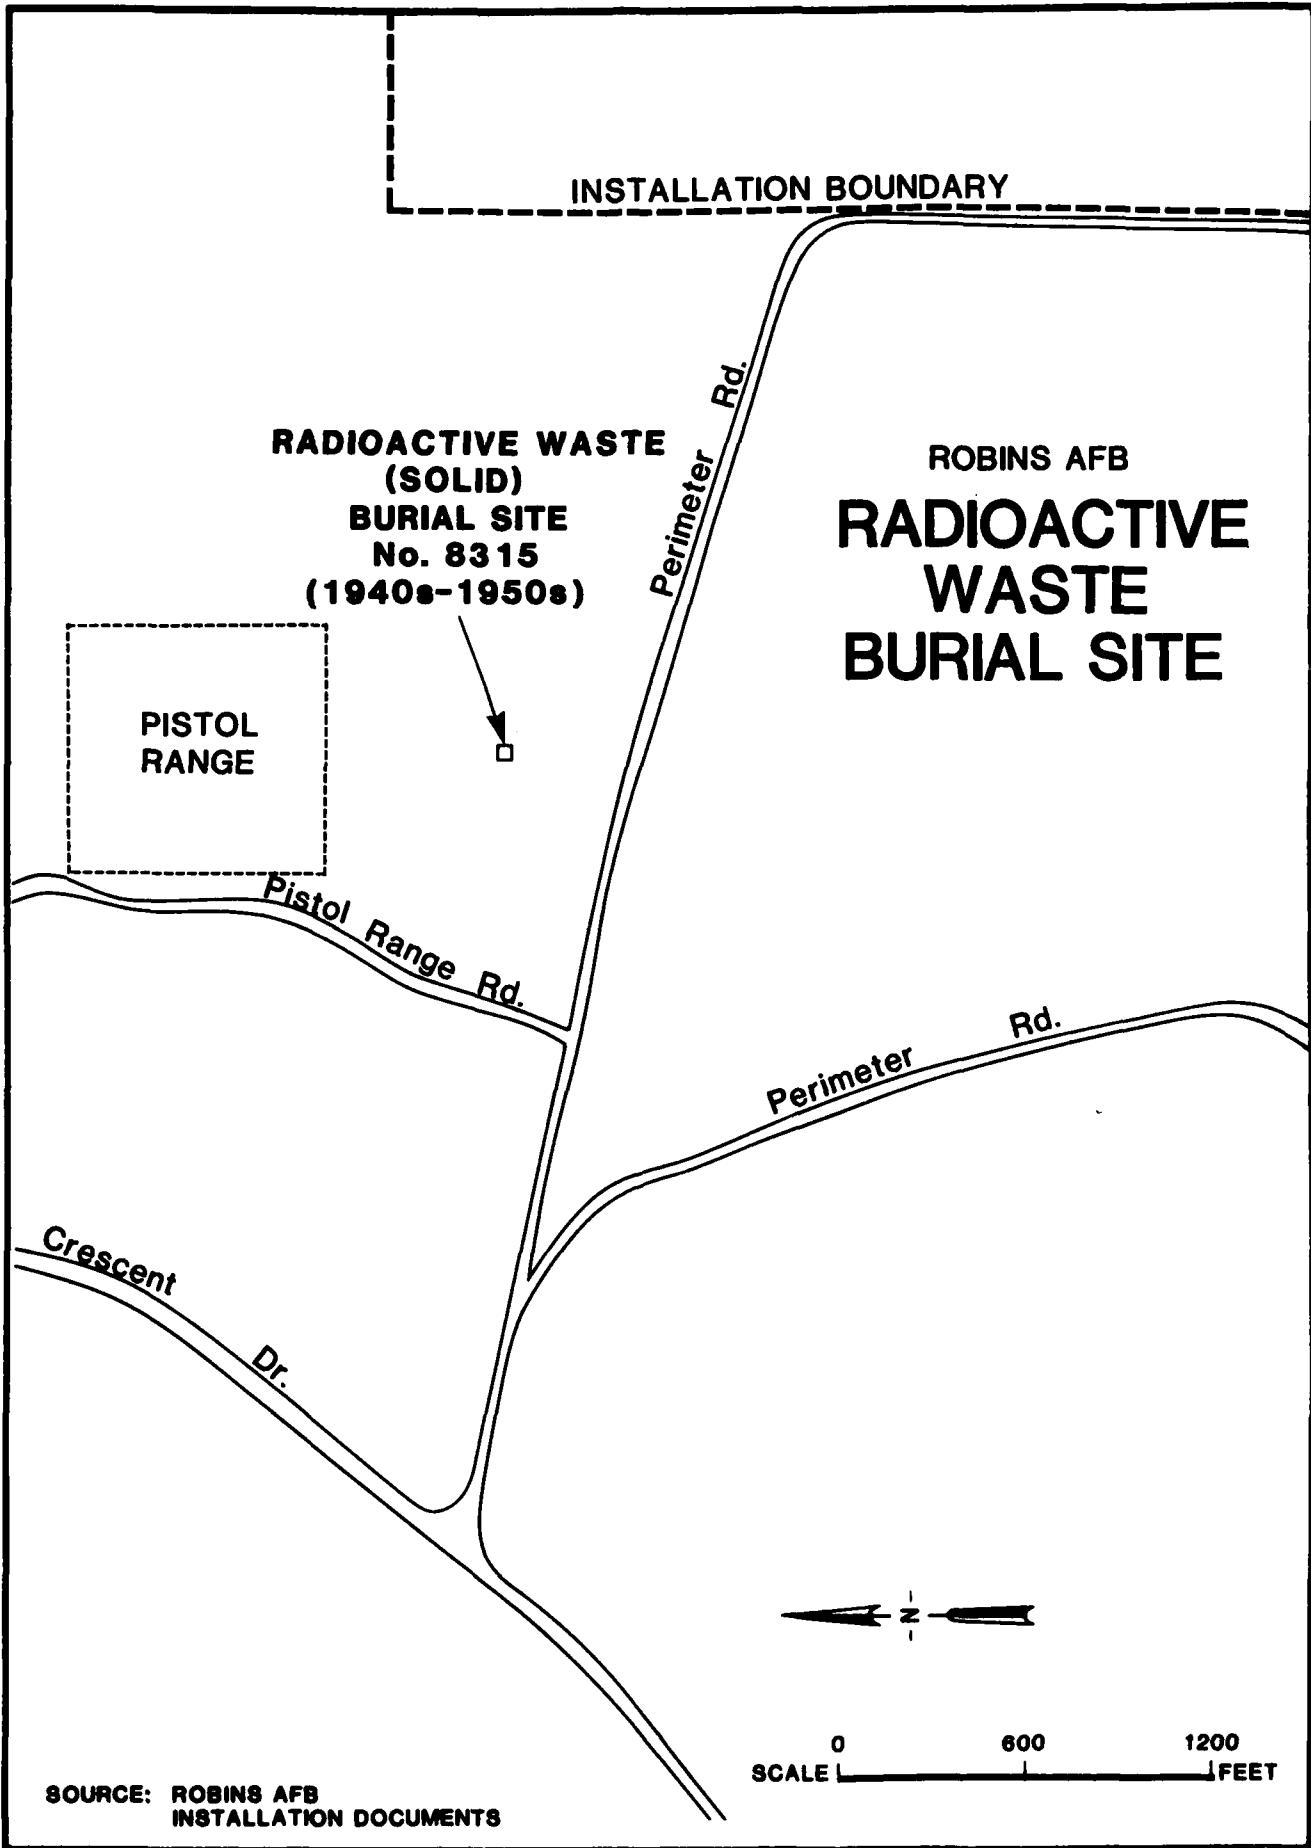
FIGURE 4.12

The radioactive waste (solid) disposal site, facility number 8315, is located, as shown in Figure 4.12, on the southeast corner of the base along Perimeter Road south of the firing range. It is comprised of a concrete vault buried approximately six feet below the ground surface. A locked chain-linked fence with two barbed wire strands surrounds the disposal area. Two signs are posted on the fence designating the area as a "Radiation Hazard Area". The site was used in the early 1950's for disposal of low-level solid radioactive wastes such as old radium dials, contaminated radioactive brushes, election tubes and spark gaps. Soil samples collected within and adjacent to the burial area have been analyzed annually. The 1980 soil analyses are presented in Table C.13 (Appendix C). The area was last surveyed with a beta/gamma radioactivity detector in September of 1981. Radiation levels did not exceed 0.03 mr/hr above a background of 0.01 mr/hr; indicating radioactive

materials are present, but do not result in radioactivity levels hazardous to human health.

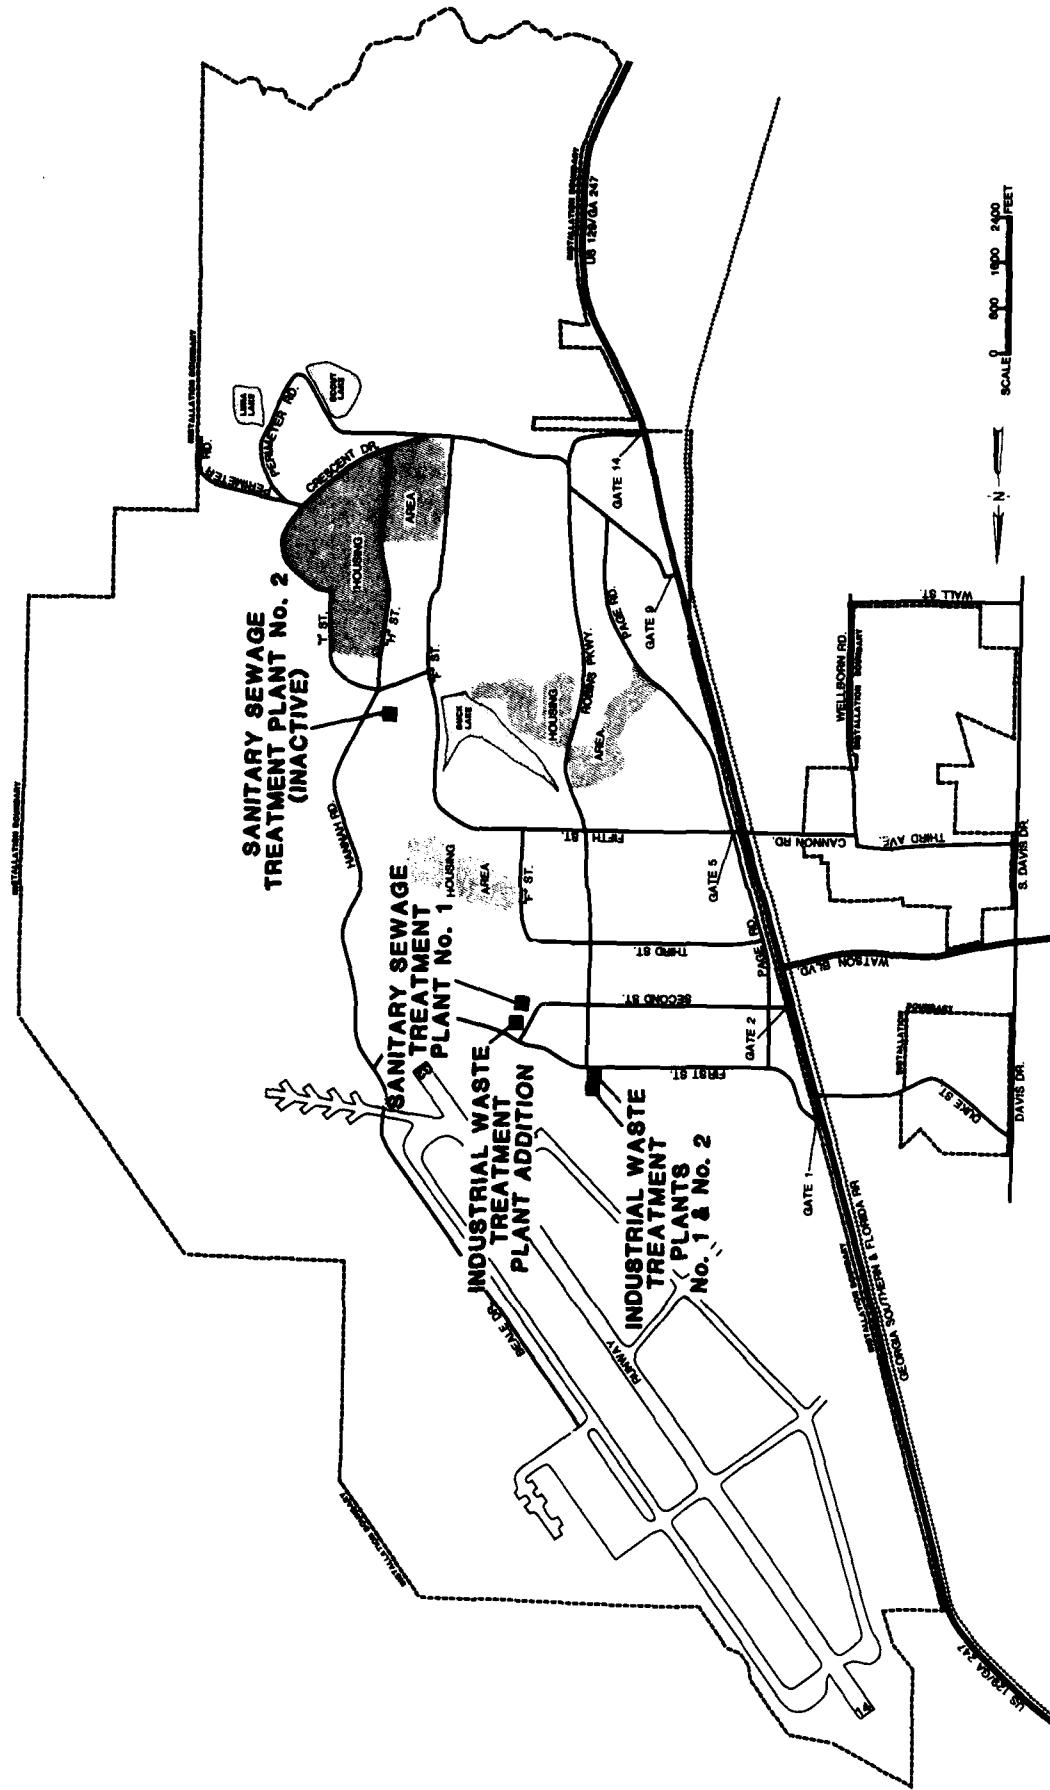
FIGURE 4.13

The sludge dewatering and disposal facility was built in 1978 as part of the closure of the sludge lagoon. The disposal building is completely enclosed with a concrete floor. Decant from sludge dewatering (plate and frame pressure filter) is returned to industrial waste treatment plant No. 1. The sludge disposal building was designed for a total dry sludge storage volume of 9,323 cubic yards and an estimated life of 10 years at current sludge generation rates. The locations of the waste treatment facilities are shown in Figure 4.13.

WASTEWATER TREATMENT FACILITIES
